2.0 Edgemont, South Dakota, Disposal Site

2.1 Compliance Summary

The Edgemont, South Dakota, Uranium Mill Tailings Radiation Control Act (UMTRCA) Title II Disposal Site was inspected on June 12, 2007, and was in excellent condition. The entrance signpost was broken, and the sign was relocated to the entrance gate. The site continues to be grazed by a local rancher in exchange for checking site security and repairing the perimeter fence. Noxious weeds persist on and adjacent to rock-covered surfaces and will require continued monitoring and control. Groundwater monitoring is not required at this site. No cause for a follow-up inspection was identified.

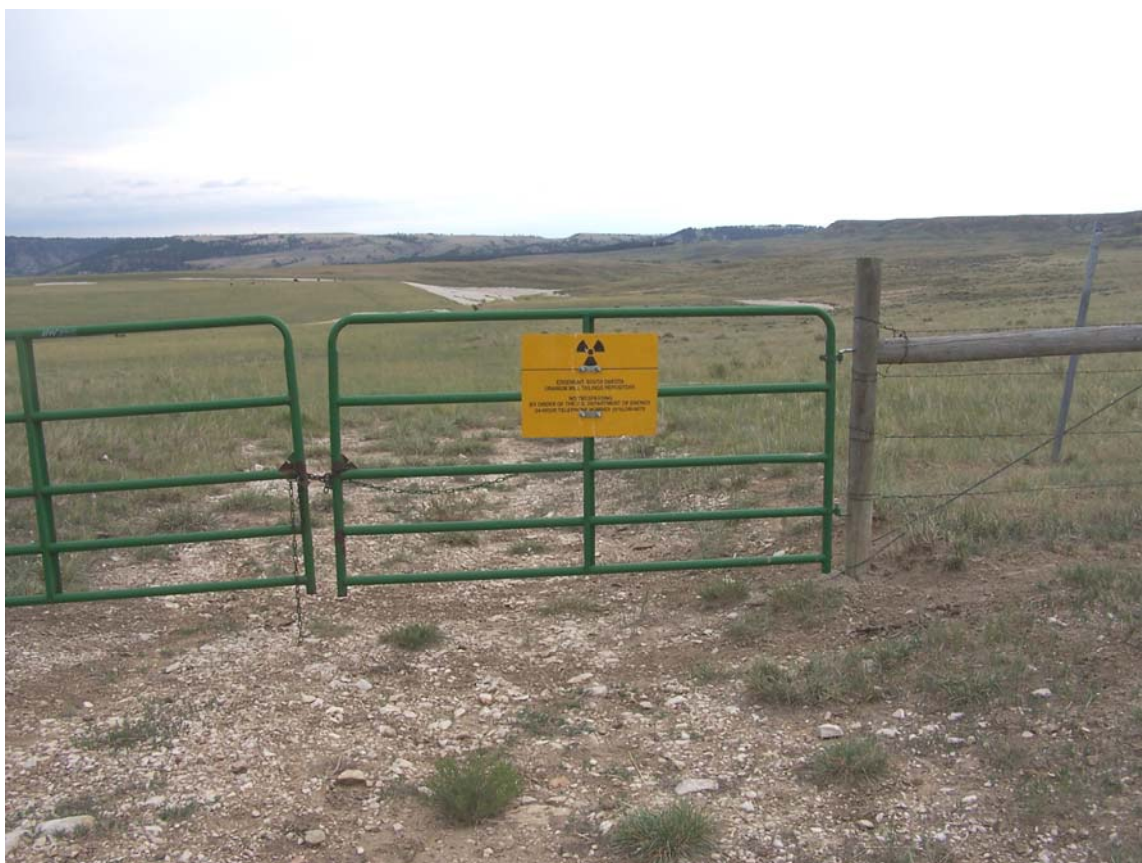
2A The entrance sign was the only warning/no trespassing sign installed at the site. At the time of the inspection, the signpost was broken and laying on the ground; the damage likely was caused by cattle. The sign was relocated to the entrance gate (PL-1), and will be moved to a new post inside the gate in 2008.

EDG 6/2007. PL-1. Entrance sign relocated to the entrance gate.

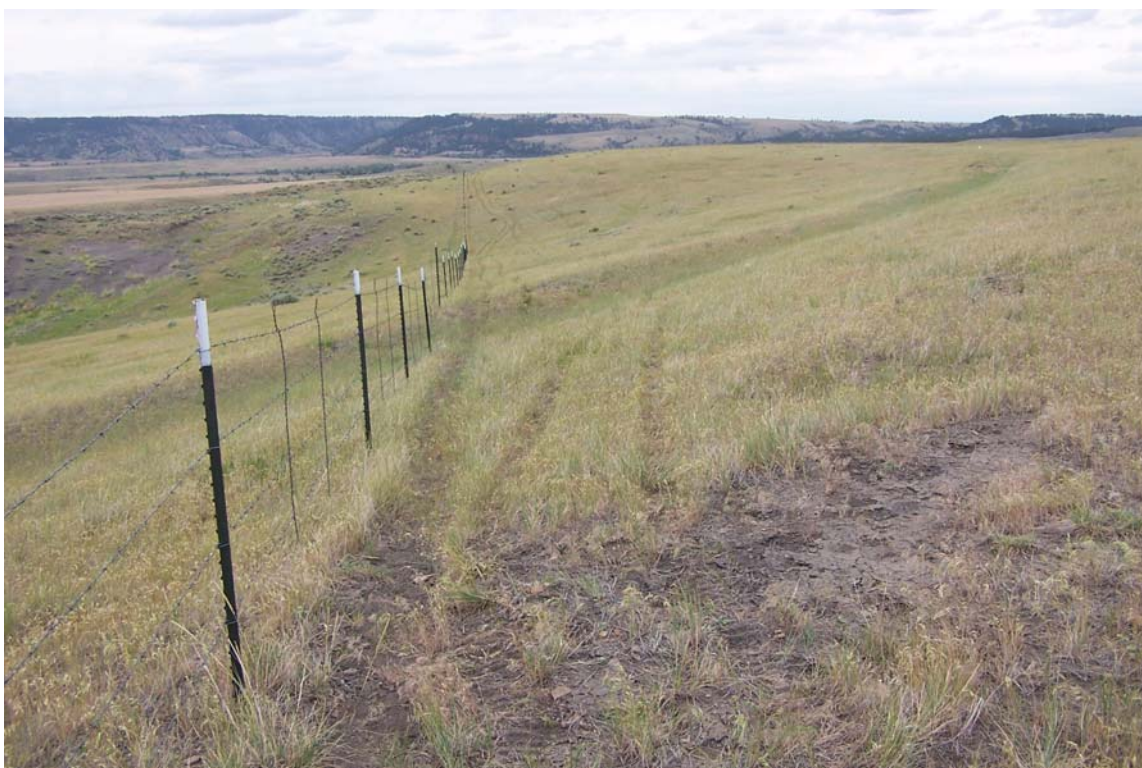
A four-strand barbed wire fence was installed in spring 1999 along the site perimeter boundary to demarcate DOE property and to control grazing on the property. The fence truncates the southeast corner to allow livestock access to a pre-existing stock pond. A grazing license granted by DOE allows a local rancher to graze the site in return for checking site security and maintaining the perimeter fence. Controlled grazing promotes turf vitality, and cattle were on the site at the time of the inspection. An all terrain vehicle was used to inspect the entire site perimeter, and the fence was in excellent condition (PL-2).

EDG 6/2007. PL-2. Perimeter fence along the north property boundary.

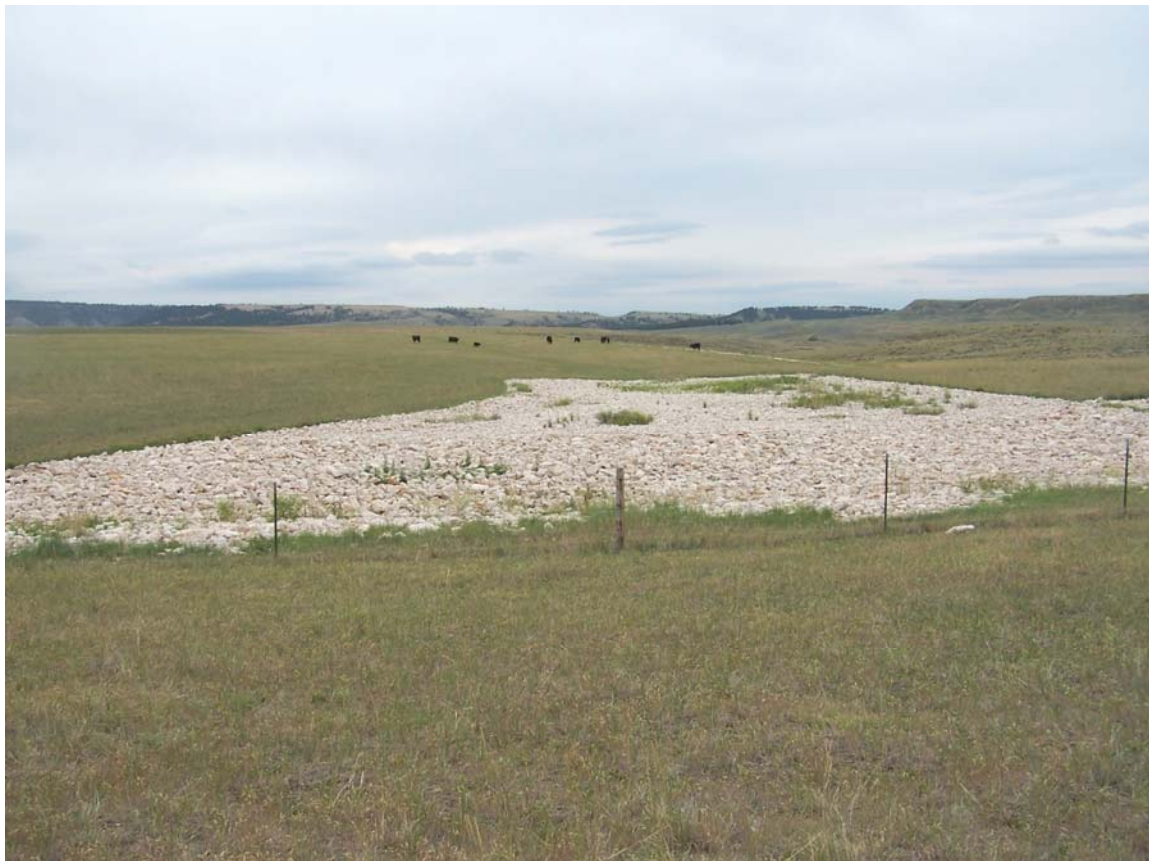
Top of the Disposal Cell—The 100-acre top of the disposal cell, completed in 1989, is grass-covered and was in excellent condition (PL-4). DOE manages the grass cover through controlled grazing. The grass is well established and was not overgrazed when inspected. Numerous cattle trails are present on the cell top, but there were no indications of erosion, settlement, or other modifying processes that might affect the integrity of the cell.

EDG 6/2007. PL-4. The west diversion channel and the grass-covered disposal cell.

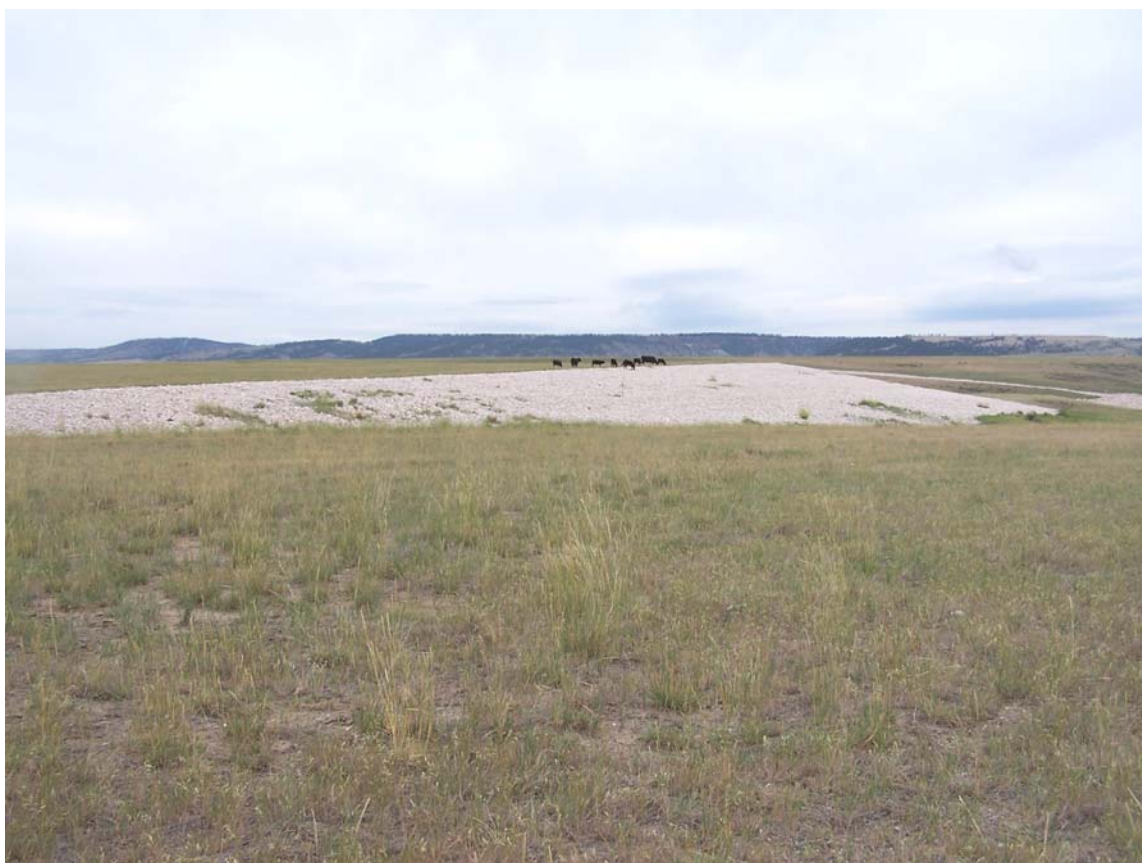
Embankment Face and Drainage and Diversion Channels—The embankment face, the steepest man-made slope on site, is covered with riprap. The slope is stable, and the riprap showed no signs of degradation. Scattered plants, mostly grass and annual weeds, grow in the riprap (PL-5). These plants do not pose a threat to the stability or function of the embankment face.

EDG 6/2007. PL-5. The face of the tailings embankment and cattle on the disposal cell top.
